Report and health check of the river Crane/Moors with specific emphasis on management for the Odonata

Bournemouth University
SERT (Student
Environment Research
Team 2016

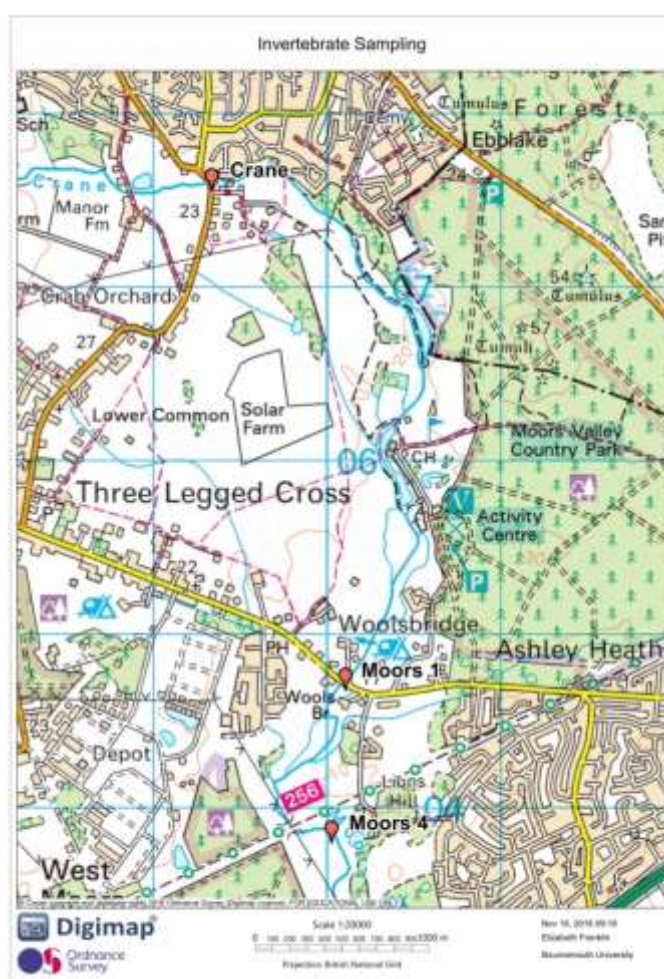
Fig 3. Locations of historical invertebrate sampling Crane (SU-09300-07600), Moors 1 (SU-10100-04700) and Moors 4 (SU-09800-03800).

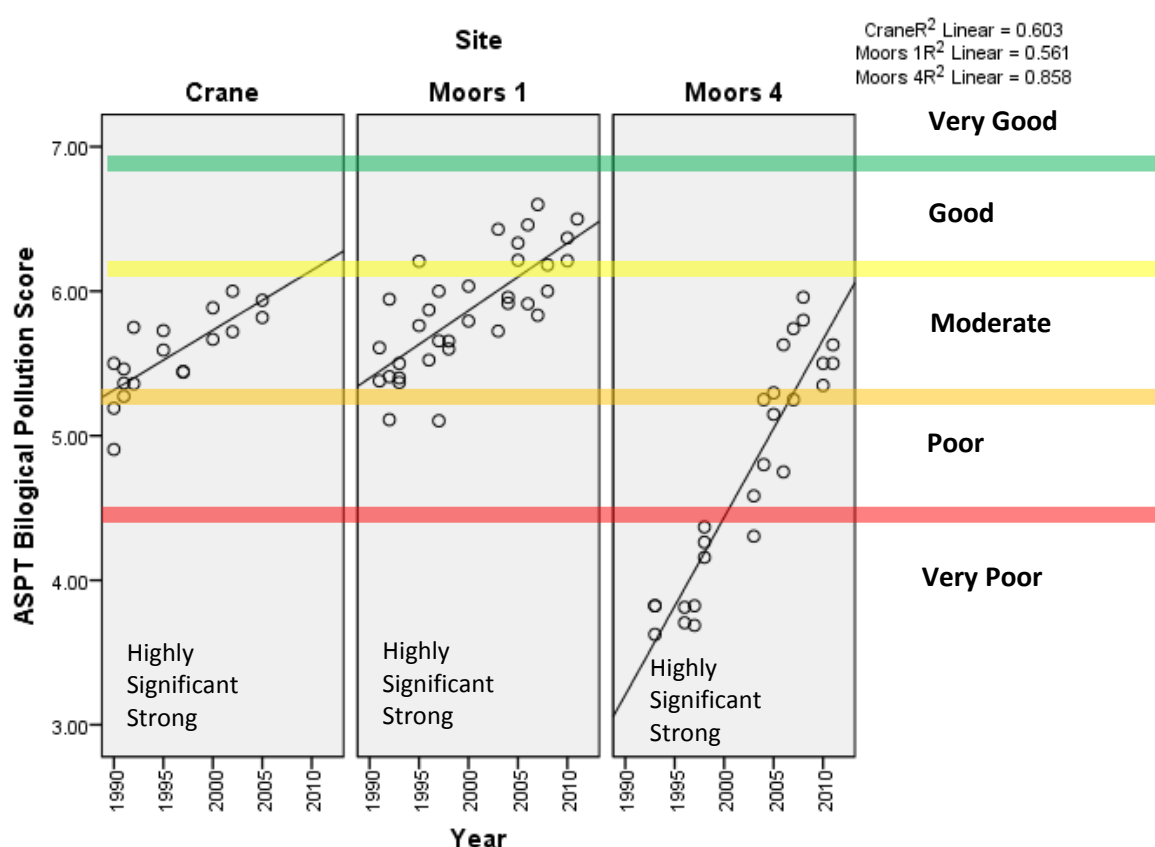
The average score per taxon, biological pollution scores for the Crane, Moors 1 and Moors 4 have improved from 1990 – 2010. The crane site (SU-09300-07600, Fig 3) has significantly improved from a poor state to a moderate state (Pearson rho 0.776 significance <0.001, Fig 4). The Moors 1 site (SU-10100-04700, Fig 3) has significantly improved from a poor state to a good state (Pearson rho 0.749 significance <0.001, Fig 4). The Moors 4 site (SU-09800-03800, Fig 3) has significantly improved from a very poor state to a moderate state (Pearson rho 0.926 significance <0.001, Fig 4).

Fig 4. The change over time in the average score per taxon biological pollution score for the Crane (SU-09300-07600), Moors 1 (SU-10100-04700) and Moors 4 (SU-09800-03800). Lines show regression lines and overall trend in biological pollution score.

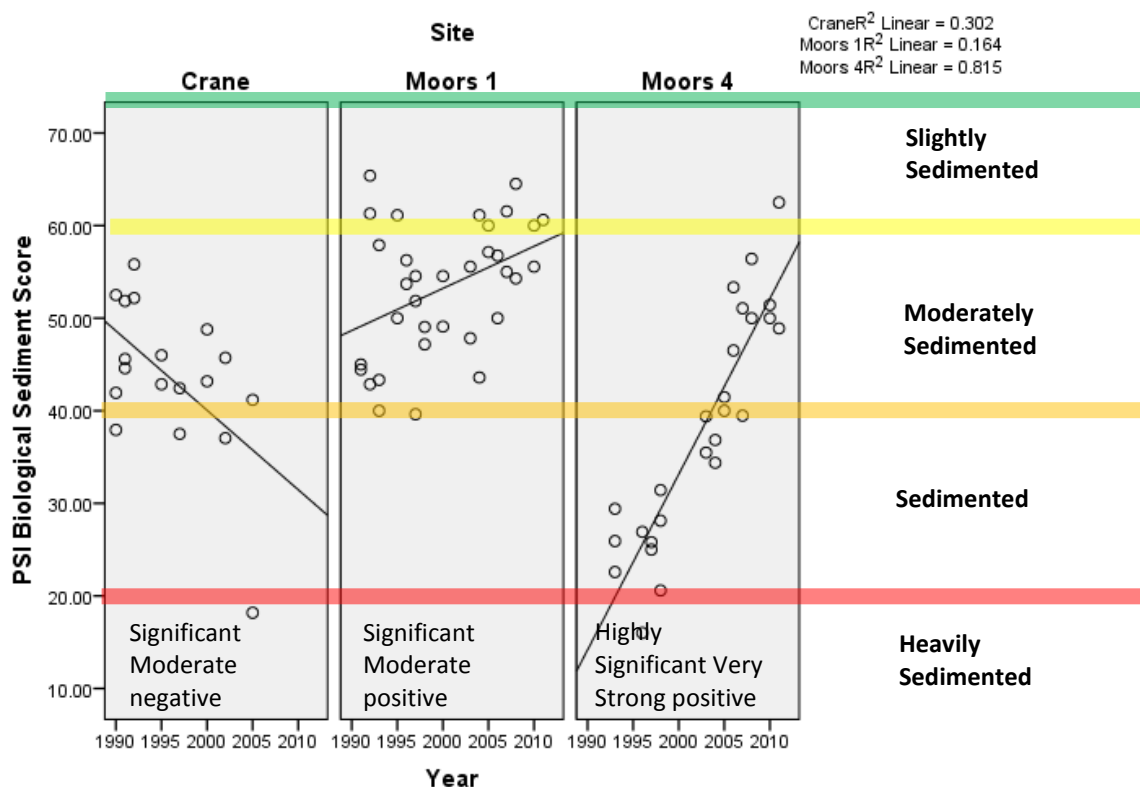
The average biological sedimentation score for the Moors 1 and Moors 4 have improved from 1990 – 2010 where at the Crane site the sedimentation score has increased. The Crane site (SU-09300-07600, Fig 3) has significantly decreased from a moderately sedimented state to a heavily sedimented state (Pearson rho -0.550 significance 0.018, Fig 5). The Moors 1 site (SU-10100-04700, Fig 3) has significantly improved from a moderately sedimented state to a slightly sedimented state

(Pearson rho 0.405 significance 0.017, Fig 5). The Moors 4 site (SU-09800-03800, Fig 3) has significantly improved from a heavily sedimented state to a slightly sedimented state (Pearson rho 0.903 significance <0.001, Fig 5)¹⁰.

This study supports the findings of the 2009 SSSI Condition report⁴ suggesting that the increased siltation in the upper Crane is changing the river biota above Moors Valley Park at the Crane Site. As the data shows a significant decline of PSI sedimentation score (Fig 5).

Fig 5. The change over time in the PSI Biological sedimentation score for the Crane (SU-09300-07600), Moors 1 (SU-10100-04700) and Moors 4 (SU-09800-03800). Lines show regression lines and overall trend in biological sedimentation score.

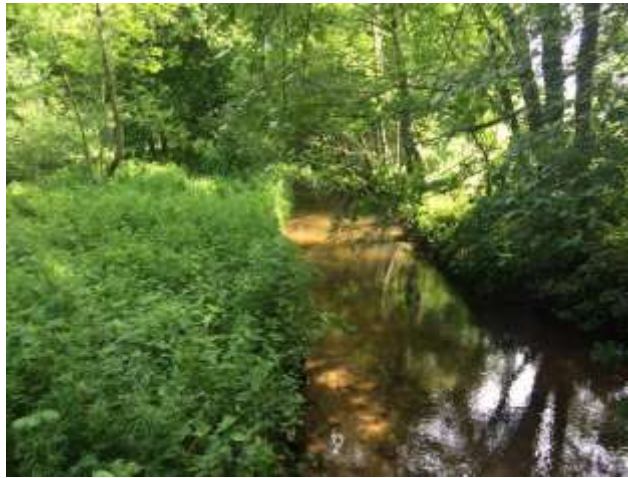
On the left bank side, trees were continuous and regularly spaced but on the right they were isolated and scattered with occasional clumps, which were semi-continuous. Shading of the channel was present. Overhanging boughs, exposed tree roots, underwater roots and large woody debris was classified as more than or equal to 33%.

Fig 11. Large tree with overhanging boughs and dense, complex vegetation on bank side at the river above Ebblake stream.

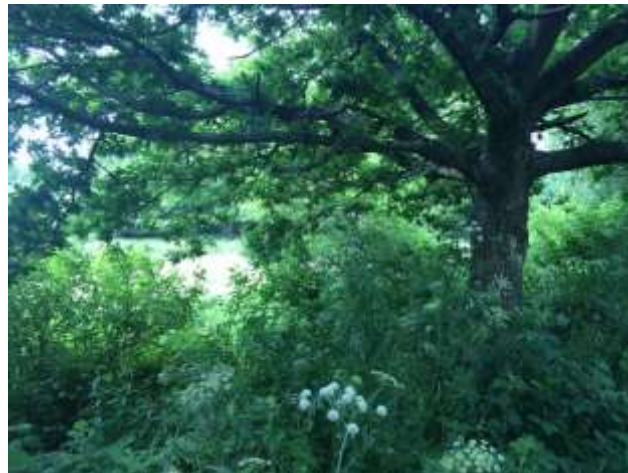
Fig 12. Area of river above Ebblake stream showing areas of shade and light.

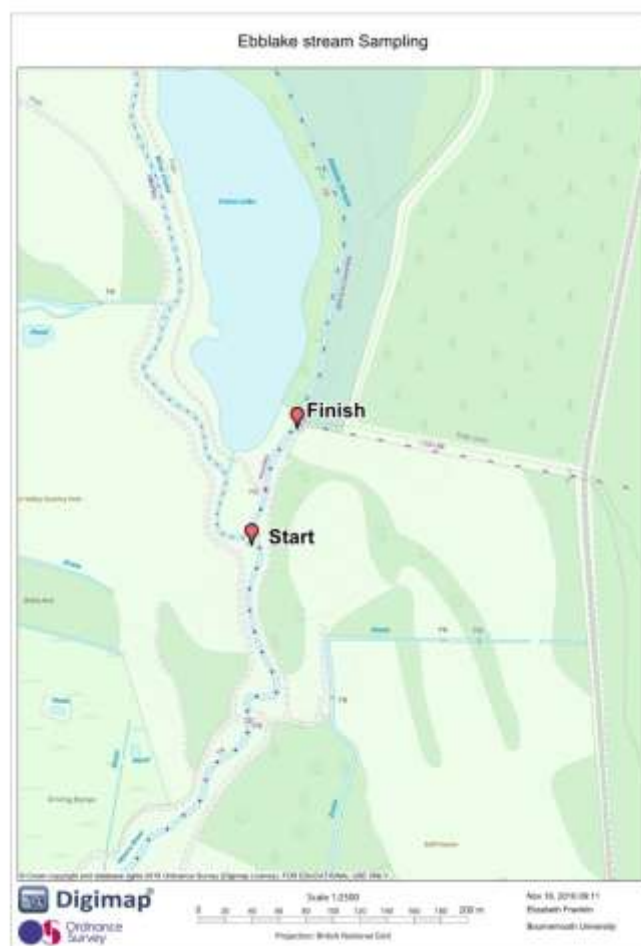
Fig 13. Ebblake stream survey stretch starting at downstream point

There was no channel vegetation and only one or two species of plant on the bank faces of the stream. No dragonflies or damselflies were observed at site one.

Again at site two, the bank height was low, with the gradient of the bank face very gentle. The flow of water was almost stationary at site two and as a result, the water appeared almost stagnant with very few signs of life and no channel vegetation. There was less canopy cover at the second site as the bank top had more scrub-like foliage with less trees.

Again, no dragonflies or damselflies were observed at this site.

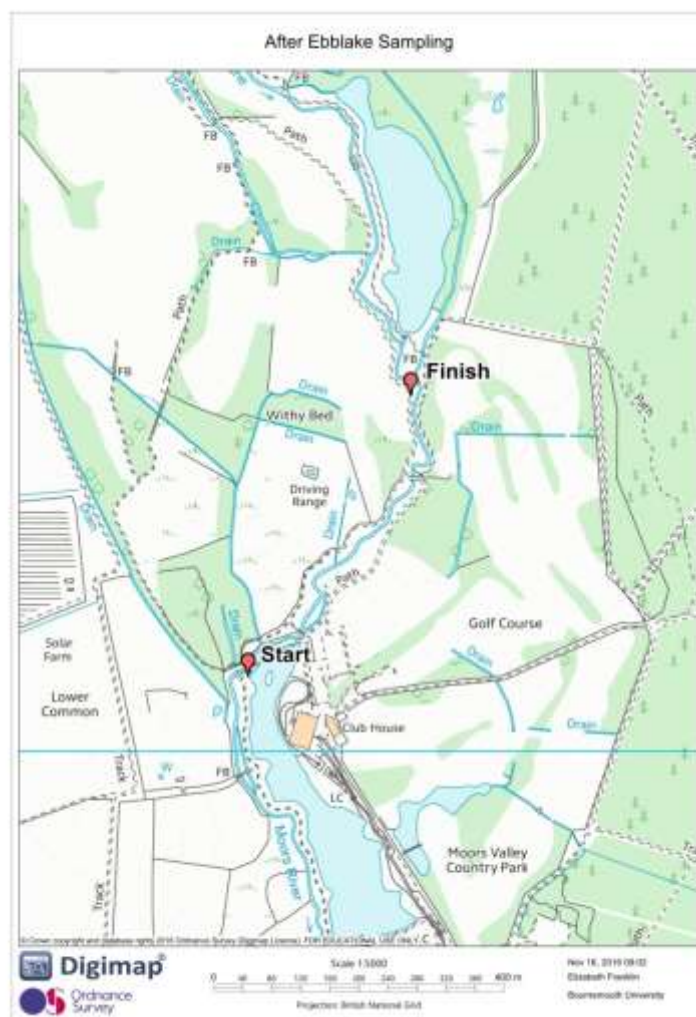
Fig 14. After Ebblake survey stretch starting at downstream point

Site two had a very similar bank structure to site one. Again both banks consisted of earth and met the river at an abrupt angle. However, the left bank top was measured to be 0.95m and was the highest bank measurement recorded throughout the entire survey. This very much contrasted with the right bank top height as was observed at 0.64m.

The vegetation lining the banks was noticeably limited in regards to number of species. With one predominant species observed on the right bank, along with only two or three species observed on the left bank.

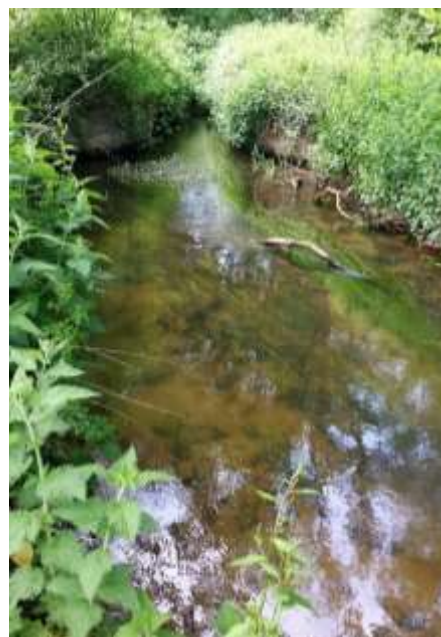
Site Two

3 damselflies spotted (suspected to be Beautiful/Banded).

In terms of amphibious and aquatic vegetation; this site was relatively diverse. There appeared to be amphibious species as well as both submerged broad leaves and submerged linear leaved.

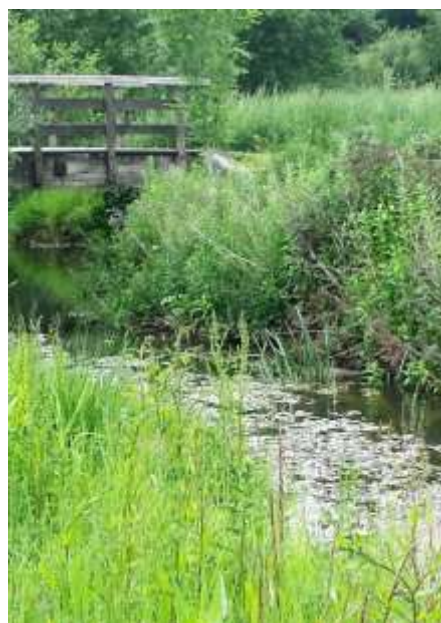
Site Three

substrate and where measured to be an equal 0.7m. The river was observed to be slightly narrower than the two previous sites which explained why the water level was slightly higher here also.

The vegetation was fairly sparse on the both banks, with the left bank face observed to be completely bare in comparison to the previous sites.

Although the bank vegetation seemed to be relatively sparse, the aquatic vegetation was fairly substantial; with species of emergent herbs, submerged broad and linear leaved present.

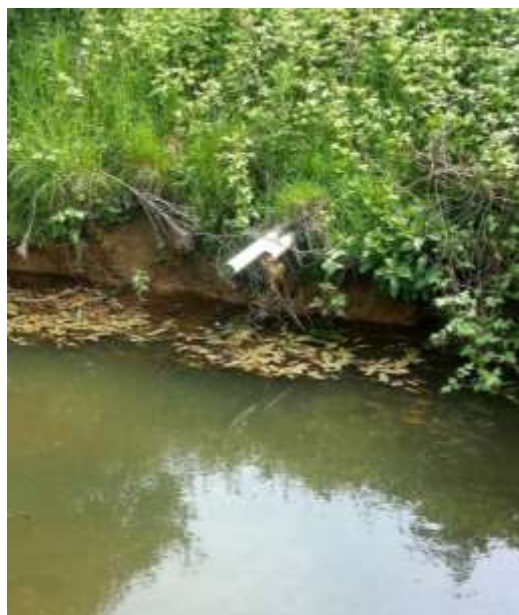
Site Five

Dragonflies and damselflies absent.

The vegetation lining the left bank was recorded to consist of predominantly one species, with two or three species spotted on the opposing bank.

The aquatic vegetation was fairly dense. Emergent broad leaved herbs, aquatic and submerged broad leaved species were spotted.

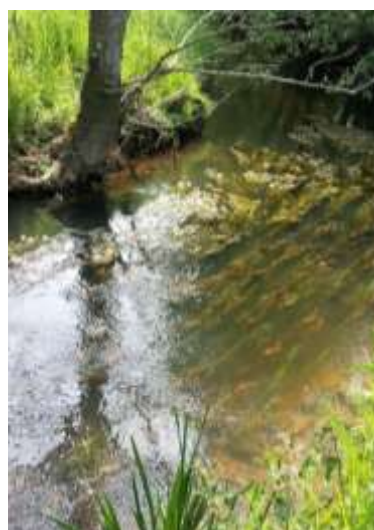
Site Six

Damselflies and dragonflies absent from area. Both banks were measured to be relatively level at 0.74m and made from earth. No bank modifications had taken place at this location.

A diseased alder tree was observed overhanging the river on the right bank, casting shade over a large proportion of the river.

The species diversity in terms of vegetation was relatively limited at this specific site. Each bank consisted of only two or three vegetation types. Emergent broad leaved herbs, floating leaves (rooted), amphibious and submerged linear leaved species were observed within the river itself.

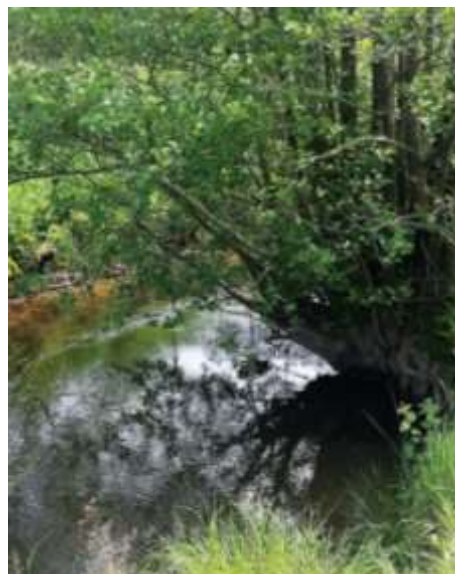
Site seven

Lots of dragonflies and damselflies (suspected Beautiful/Banded)

There was a lack of diversity in terms of bank vegetation with only one dominant species appearing consistent on both banks at this specific site.

Emergent broad leaved herbs, aquatic and submerged broadleaved species were recorded to be situated within the river.

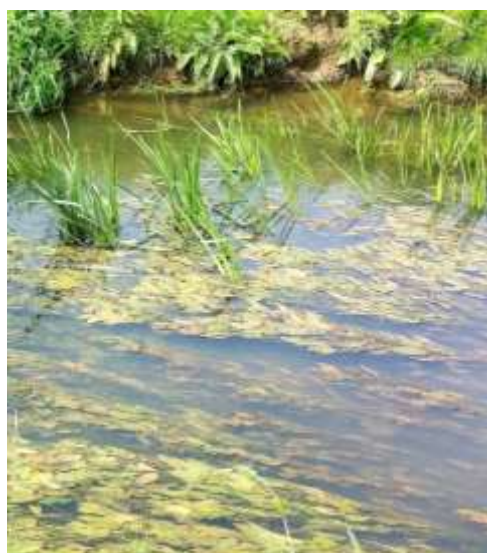
Site eight

Very little dragonfly and damselfly activity.

The vegetation was recorded to be fairly limited in diversity, with one dominant species consistent on the left and right bank.

In terms of aquatic vegetation, this site proved to be the most diverse when compared to the previous sites; with species of: emergent broad leaved herbs, floating leaves (rooted), amphibious, submerged broad and linear leaved species present.

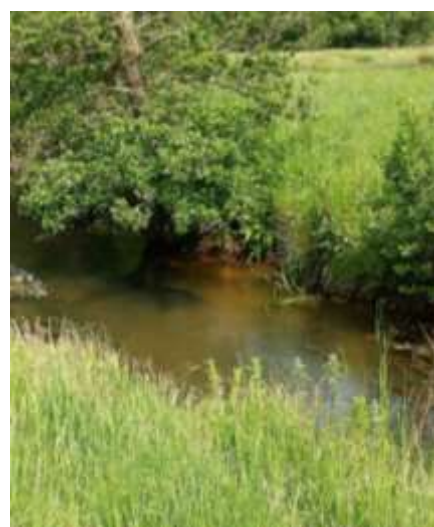
Site nine-

No damselfly or dragonfly activity.
Both banks were noticeably steep and made of earth.
Alder trees were observed on the left bank, providing dense coverage to this portion of the river. The remaining vegetation consisted of one predominant species, along with areas of bare ground.
Emergent broad leaved herbs, rooted floating leaves, amphibious and submerged broad leaved species were present within the river.

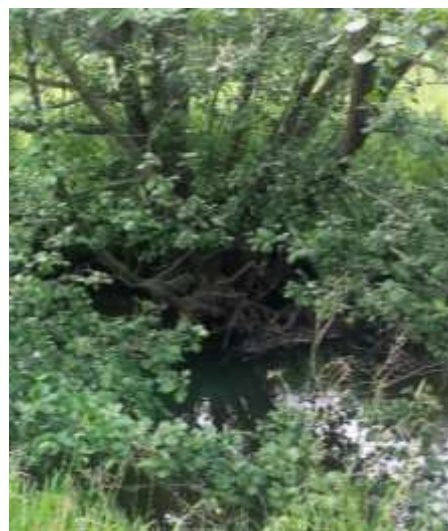
Site Ten

No damselfly or dragonfly activity.
The formation of both banks closely resembled that of the previous site; relatively steep and consisting of an earthy substrate.
In terms of bank vegetation, this site was very similar to the previous site too. With one predominant species observed along with areas of bare ground.
This was the only site on the entire survey in which aquatic plant species were completely absent.

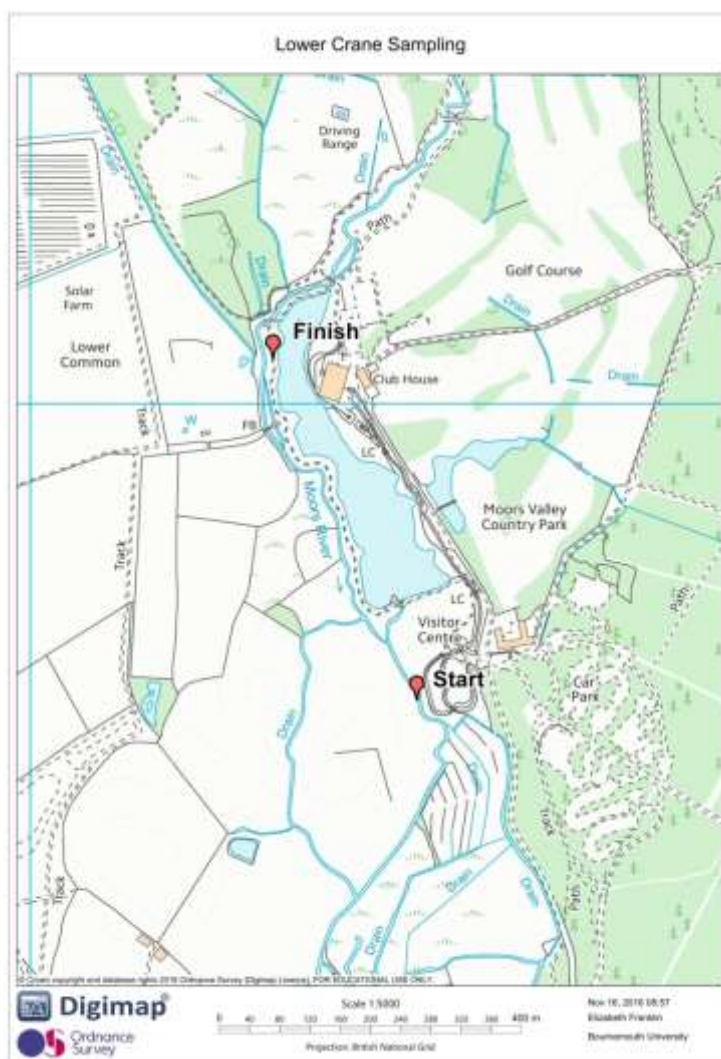
Fig 15. Lower Crane/Moors survey stretch starting at downstream point

Due to lack of access or unstable unsafe ground many points of the bank could not be analysed for measurements in particular the right side of the river bank.
